Weather Station Maintenance in Southwest Alaska Network Parks

Summary for the 2013 Hydrologic Year

Natural Resource Data Series NPS/SWAN/NRDS—2013/592

Chuck Lindsay

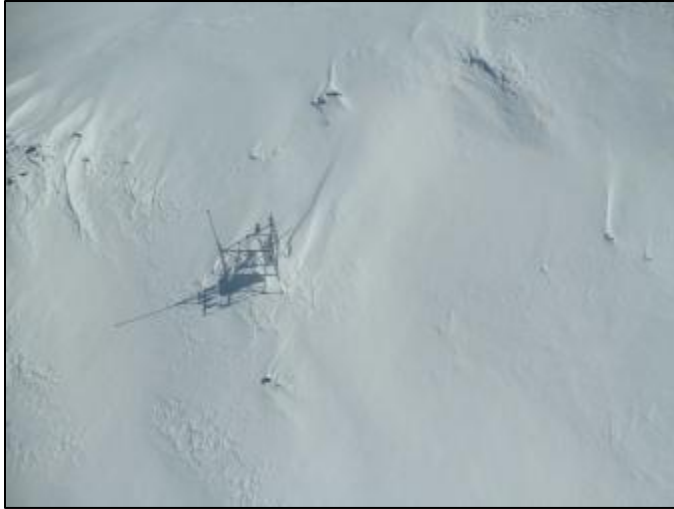
Maintenance of Chigmit Mountains weather station was done on the same day as maintenance on Fourpeaked weather station. A round-trip helicopter flight was made from Homer with a refueling stop in Port Alsworth (at Lake and Pen Air). The station had been badly damaged by rime ice (Figures 2 and 3) and the 20-ft wind sensor mast had broken and both wind sensors were wrecked. This mast was replaced with a new one that was reinforced by welding a smaller diameter aluminum pipe inside the mast in order to reinforce the junction which had broken. All guy-wires and associated hardware were also replaced. The AT-RH sensor, WS sensor and cable, WD sensor and cable were replaced. A WD sensor direction test was done. The rain count for the tipping bucket was zeroed, and a tipping bucket test was done. All data in the data logger were downloaded to send to the WRCC in order to update the archive. The SD sensor was replaced with a Campbell Scientific SR50 SD sensor, which was rehabbed with new transducer plates and desiccant. Data logger program CHMO_DLP_SR50.prg was edited to zero the SD sensor. Snow depth was zeroed to an average reading of -0.5 inches to account for fluctuation without reporting misleading snow depth readings. In stark contrast to June of 2012, there was no snow present directly at the station at the time of maintenance. All bolts on the station were checked and tightened if loose and all cables were zip-tied. Station observations and GOES transmission quality were checked before departure. Observations and transmissions were verified from the WFMI website and relayed by satellite phone. Before departure the station was photographed from eight directions (every 45°, Figure 4) and the inside of the instrument enclosure (Figure 5) was also photographed.

Figure 2. Chigmit Mountain RAWS – Station photographed on April 2, 2013 showing broken mast.

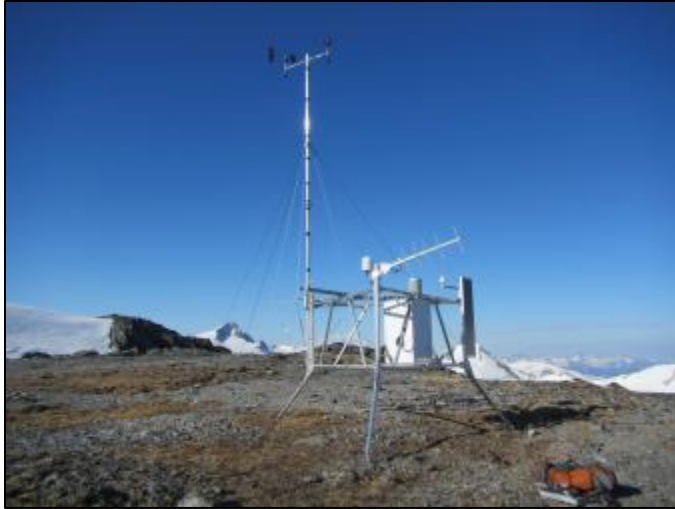
Figure 4. Chimgit Mountain RAWS – Station after maintenance photographed from southwest.

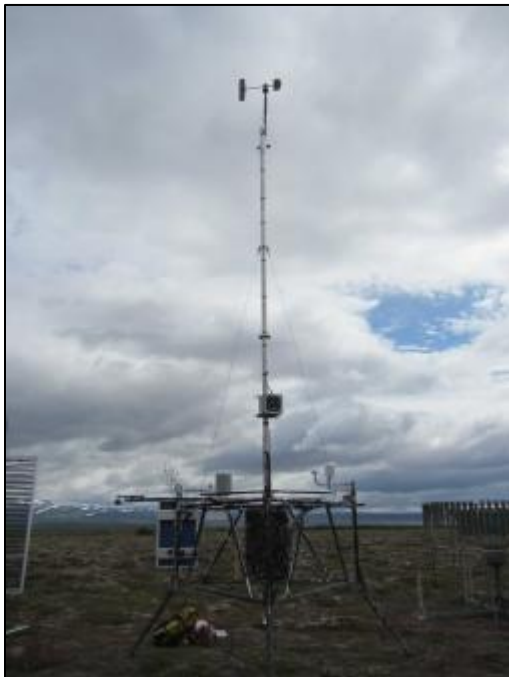
The Harbotronics time lapse camera (Figure 7) was maintained. The 32 GB SD card was exchanged for an empty one and the desiccant packs were replaced. The camera collected four RAW-format photos/day between August 16, 2012 and June 24, 2013. The intervalometer programming was not changed. Before departure a thin film of silicone grease was applied to the gasket on the housing door with an irrigation syringe to help maintain a seal.

Figure 7. Contact Creek RAWS – Harbortronics time lapse camera housing visible mounted to wind sensor mast.

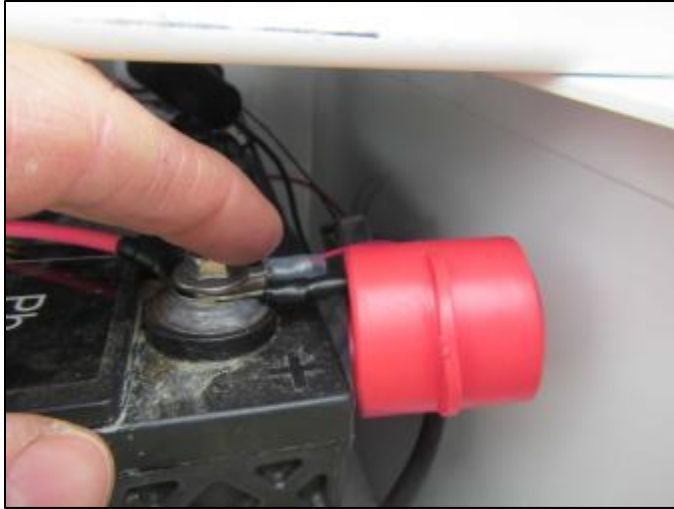
Campbell Scientific time lapse cameras were installed at all Phenocam sites in 2012 in order to replace the Harbotronics cameras after a year or so of overlap in operation. The rationale was that this equipment had a better housing that would protect the camera from moisture and that it would also be easier to maintain in the field (graphical instead of command line laptop interface and reduced likelihood of accidentally changing focus and zoom). The newer Campbell Scientific camera was maintained. The 16 GB SD card was exchanged for an empty one and the tiny desiccant packs were replaced. The camera collected 13 JPG-format photos/day between August 1, 2012 and January 19, 2013 when the camera apparently stopped working. Battery voltage was 2 V. It is assumed the camera did not switch into a low power state and therefore drained the battery during winter low-

Figure 8. Contact Creek RAWS – Campbell Scientific time lapse camera was directly powered off the 100 Ah batteries. Note thin red wire from positive battery terminal to the camera cable.

light conditions. The separate 35 Ah battery and charge controller were removed and the camera was directly connected to the two 100 Ah batteries that charge the weather station (Figure 8).

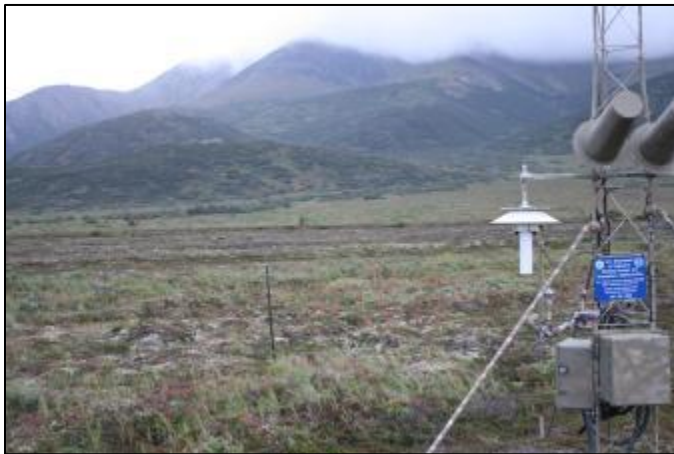
The Harbortronics time lapse camera was moved to the CRN solar panel array. The 32 GB SD card was exchanged for an empty one and the desiccant packs were replaced. The camera collected four RAW-format photos/day between June 25, 2013 and September 3, 2013. The intervalometer programming was reprogrammed with the same parameters. Before departure a thin film of silicone grease was applied to the gasket on the housing door with an irrigation syringe to help maintain a seal. The camera was connected to a 100 Ah battery, solar charge regulator, and 10 W solar panel that were attached to, or stored within, the CRN battery enclosure. The new field of view for the camera is shown in Figure 11. It was intended to match the old field of view as much as possible.

Figure 11. Contact Creek RAWS – Field of view for Harbortronics time lapse camera after being moved to Climate Reference Network station.

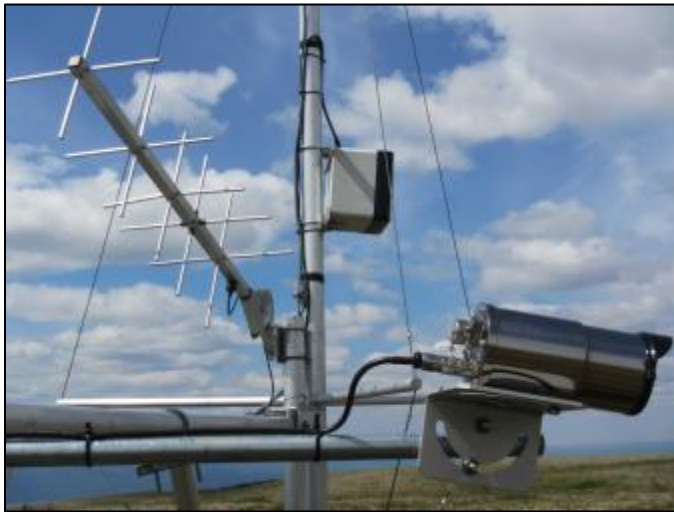
The Harbotronics time lapse camera (Figure 15) was maintained. The 32 GB SD card was exchanged for an empty one and the desiccant packs were replaced. The camera collected four RAW-format photos/day between June 20, 2012 and June 25, 2013. The intervalometer programing was not changed. Before departure a thin film of silicone grease was applied to the gasket on the housing door with an irrigation syringe to help maintain a seal.

The newer Campbell Scientific time lapse camera (Figure 15) was also maintained. The 16 GB SD card was exchanged for an empty one and the tiny desiccant packs were replaced. The camera collected 13 JPG-format photos/day between June 21, 2012 and October 3, 2013 when the camera apparently stopped working. Battery voltage was <2 V. It is assumed the camera did not switch into a low power state and therefore drained the battery during winter low-light conditions. The separate 35

Figure 15. Coville RAWS – Harbortronics time lapse camera housing (beige box) mounted to wind sensor mast and Campbell Scientific time lapse camera (foreground).

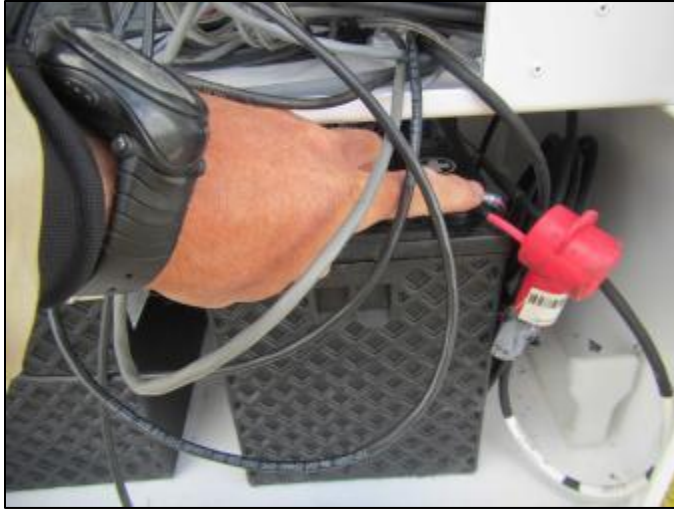
Figure 16. Coville RAWS – Campbell Scientific time lapse camera was directly powered of the 100 Ah batteries. Note thin red wire from positive battery terminal to the camera cable.

Ah battery and charge controller were removed and the camera was directly connected to the two 100 Ah batteries that charge the weather station (Figure 16).

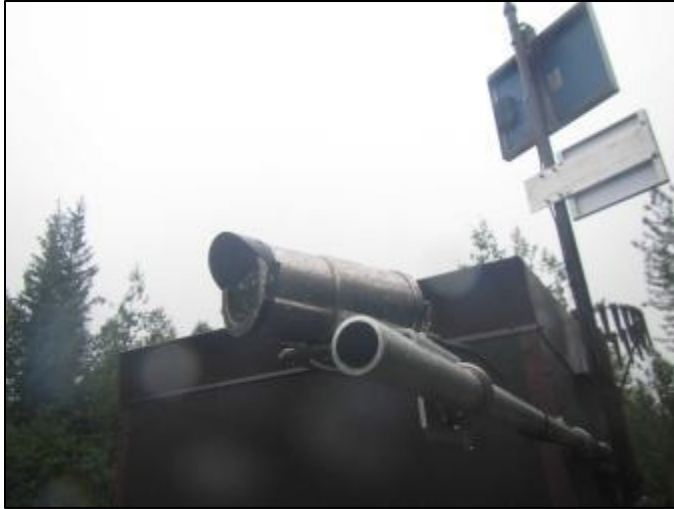
An unscheduled maintenance visit to the Exit Glacier phenocam was made because of the poor performance of the Campbell Scientific CC5MPX cameras at other weather stations. The camera was operating normally. The 16 GB SD card was exchanged for an empty one and the tiny desiccant packs were replaced. The camera collected 13 JPG-format photos/day between May 2, 2012 and August 9, 2013. Battery voltage was good and receiving charge from the solar panel. The solar panel was moved to face south to achieve maximum solar gain during winter months (Figure 19). The battery was replaced with a 100 Ah battery for increased capacity (Figure 20). The solar charge regulator was replaced with a SunSport 6 amp charger manufactured by EcoEnergy (Figure 20). Initially it was thought that solar charge regulator failure was responsible for the failure of the other Campbell Scientific phenocams and that is why the charge controller was replaced. However, correspondence with Campbell Scientific indicates that there are hardware issues with cameras with serial numbers that precede 1200. Apparently these earlier models sometimes fail to switch into a low power or 'off state'. The Exit Glacier phenocam is the only Campbell Scientific phenocam that SWAN operates with a serial number > 1200.

Figure 19. Exit Glacier phenocam – The solar panel was moved to a higher location and now faces south.

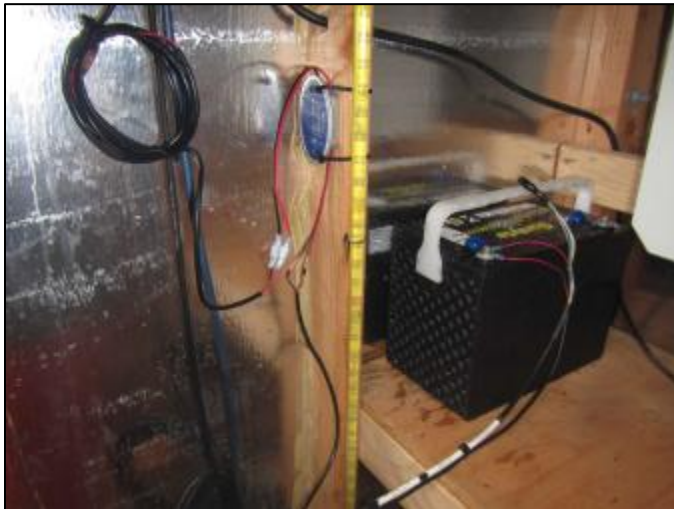
Figure 20. Exit Glacier phenocam – The power supply was changed to incorporate a 100 Ah battery and new charge regulator.

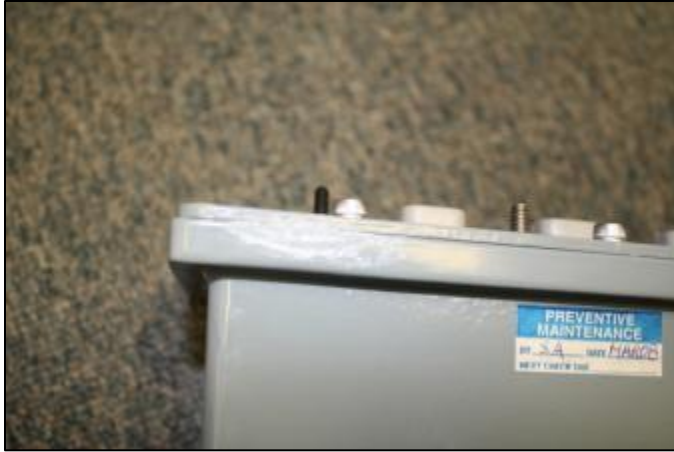
Access to the Fourpeaked weather station was by helicopter from Homer. The station appeared to be in good condition with no visible damage, but it was not working. Station stopped transmitting on September 2, 2012. Upon arrival there were no fault lights indicated on the GOES transmitter. Problems were experienced communicating with the data logger using FTS toolbox. The error message “Error 301: Unable to wake device” was repeatedly received and communications were never established. Thus data was never retrieved. The data logger, GOES transmitter, power manager, GOES antenna (oriented to 159 degrees true and inclination of +16 degrees) and cable, and GPS antenna and cable were all replaced because it wasn’t clear which component was faulty. It was clear that the data logger wasn’t working, but it wasn’t obvious what caused it to fail. This problem was previously experienced on June 16, 2012 and the station was subsequently repaired on July 17, 2012. Due to the cost of accessing this station everything that might have contributed to the problem was replaced. Battery voltage was good and both batteries had been replaced on June 7, 2012 so they were not replaced during this visit. Some corrosion was present on the base of the power manager (Figure 22) and on the GOES antenna where the antenna elements are attached (Figure 23). The solar radiation sensor was also replaced because the sensor had a short cable and, because its cable couldn’t be routed properly, it was vulnerable to damage by storms and wildlife. The replacement sensor cable has an armored housing. Station observations and GOES transmission quality were checked before departure with FTS support. Observations and transmissions were verified from the WFMI website by NIFC staff and relayed by satellite phone. Before departure the station was photographed from eight directions (every 45°) and the inside of the instrument enclosure (Figure 24) was also photographed.

Figure 22. Fourpeaked RAWS – Corrosion present on base of power manager.

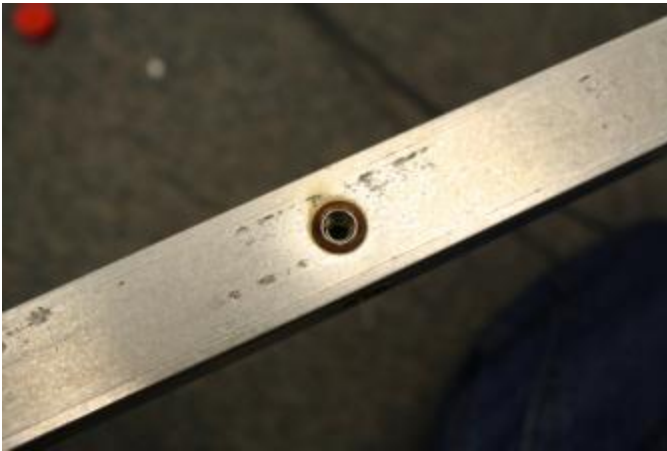
Figure 23. Fourpeaked RAWS – Corrosion present on GOES antenna.

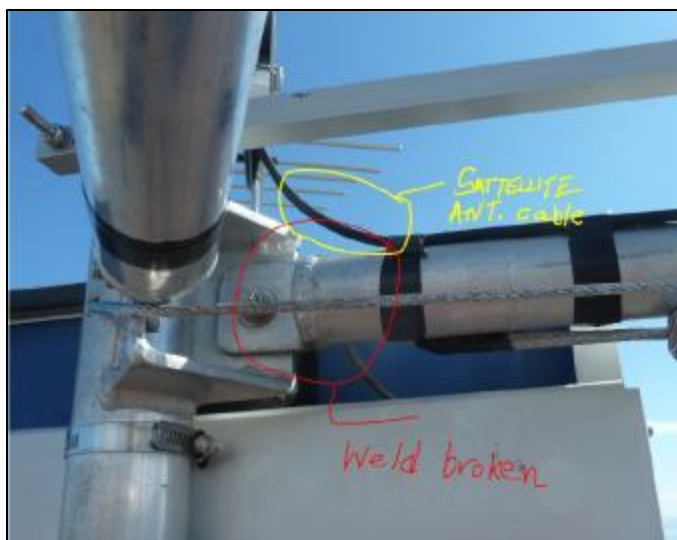
A replacement frame (three Tri-Leg Tower panels) was dropped off by helicopter (Pathfinder Aviation) during the week prior to annual maintenance. Because this flight was transporting an external load, passengers were not permitted. Access to the Fourpeaked weather station for maintenance was by helicopter from Homer on the same day as the trip to the Chigmit Mountains weather station. The station was in good condition, although not transmitting. Previous maintenance indicated that there were breaks to the welds on two of the tri-leg tower panels. This detail is important because the GOES satellite antenna coaxial cable was damaged – probably by vibrations at one of the broken welds (Figure 25) caused by wind. For this reason, the station hadn't transmitted since January 2013.

Figure 25. Fourpeaked RAWs – Broken frame weld and damaged GOES satellite antenna cable.

Two of the three tower panels were replaced. A third replacement panel was cached adjacent to the weather station. All guy-wires and associated hardware were replaced. All bolts on the station were replaced and sensor cables were zip-tied to the new frame. The data logger (12S version 6.7), GOES transmitter, GOES antenna cable, AT-RH sensor, WS sensor, WD sensor were replaced. Both wind sensors on this station are replaced each year because of harsh conditions at the site. A WD sensor direction test was done. The rain count for the tipping bucket was zeroed, and a tipping bucket test was done. All data in the data logger (October 10, 2012 to June 12, 2013) were downloaded to send to the WRCC in order to update the archive. Data logger program FOUR_DLP_SR50A.prg was loaded on the replacement data logger and the GOES transmitter was properly configured. Station observations and GOES transmission quality were checked before departure. Observations and transmissions were verified from the WFMI website and relayed by satellite phone. Before departure the station was photographed from eight directions (every 45°, Figure 26) and the inside of the instrument enclosure (Figure 27) was also photographed.

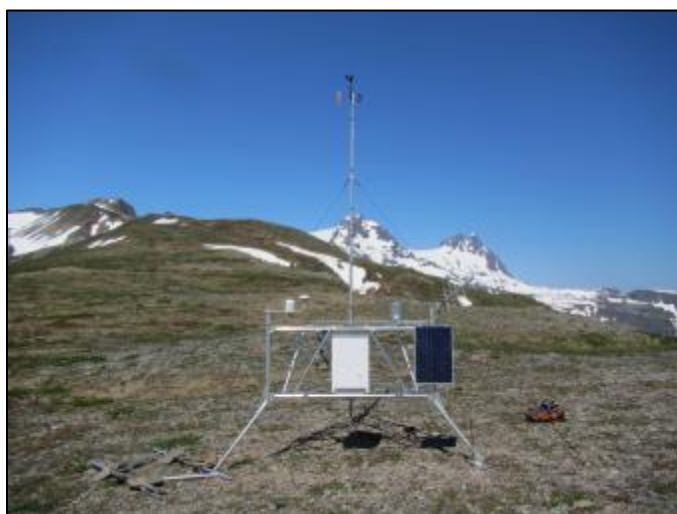
Figure 26. Fourpeaked RAWs – The tower frame panels were replaced and an extra panel was cached.

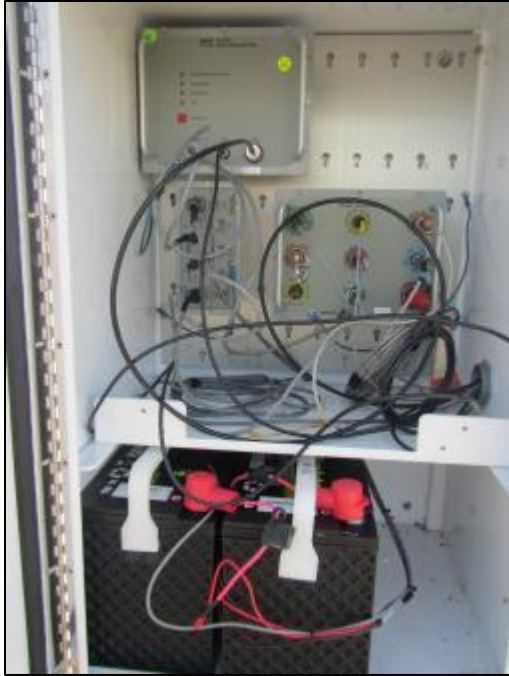
Figure 27. Fourpeaked RAWS – The inside of the instrument enclosure with new data logger and GOES transmitter.

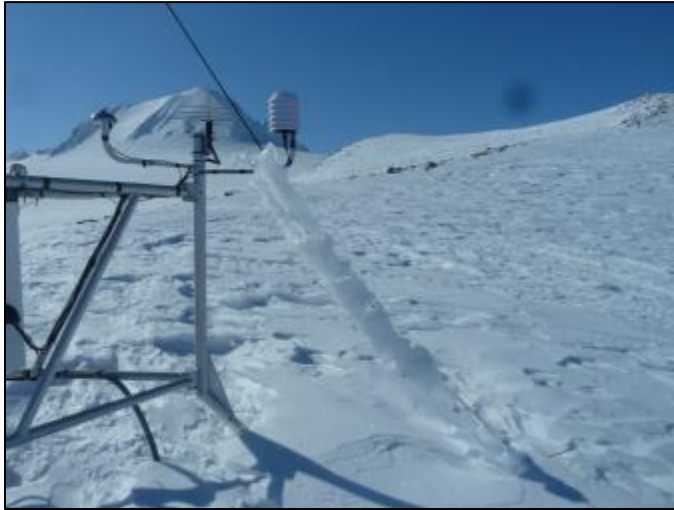
Access was by helicopter from Seward. This work took place in conjunction with KEFJ glacier mass balance field work but helicopter expenses were paid for by the I&M program. The station was in good shape but there was some rime ice attached to it (Figure 28). There were also a few snow machine tracks (Figure 28) and cigarette butts adjacent to the weather station. Some of the wind baffles on the precipitation gauge alter shield were upside down. These were repositioned. The AT-RH sensor, SR, WD sensor, and the WS sensor were replaced. Both wind sensors on this station are replaced each year because of the harsh conditions at the site. A WD sensor direction test was done. The SD sensor was replaced with a Judd Communications SD sensor that had been rehabbed with a new transducer plate and desiccant. The plastic pyramid on top of the old sensor came off as the old SD sensor was removed and will need to be glued back on using 'liquid nails' adhesive. All data were downloaded from the data logger to send to WRCC in order to update the archive. Data logger program HAIC_DLP_JUDD.prg was edited to zero the SD sensor. Snow depth was zeroed to an average reading of -0.5 inches to account for fluctuation without reporting misleading snow depth readings. The all-weather precipitation gauge was serviced by draining the antifreeze/alcohol/water solution and replacing it with a fresh solution. The tipping bucket was replaced, the rain count for the tipping bucket was zeroed, and a tipping bucket test was done. Lightweight hydraulic oil was poured on top of the antifreeze solution instead of regular motor oil. It is hoped that it will be less viscous during extremely cold periods and cause less snow bridging on top of the gauge. All bolts on the sensor arms and the tower and the guy-wires were tightened. Station observations and GOES transmission quality were checked before departure. Observations and transmissions were verified from the WFMI website by satellite phone. Before departure the station was photographed from eight directions (every 45°, Figure 29) and the inside of the instrument enclosure (Figure 30) was also photographed. Three new padlocks and WD-40 will be necessary during the next maintenance visit. It is also recommended that two Tyvek suits, two pairs of rubber gloves, a whole roll of paper towel,

Figure 28. Harding Icefield RAWS – Rime ice was present on all the guy-wires and snow machine tracks are visible in the background.

and a large trash bag be brought the next time the gauge is serviced. A ball-valve assembly for the drain hose would also be useful to prevent spillage.

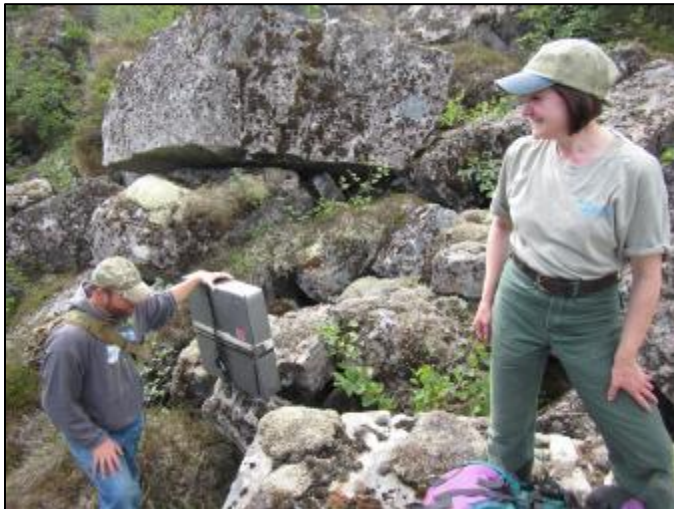
Access to this station remains challenging and potentially unsafe. For this reason, an administrative decision (Lindsay 2013a, PEPC project number 46082) was made to relocate this weather station to Silver Salmon Lakes, approximately 10 miles to the northeast. The Hickerson Lake weather station will remain in operation until mid-summer 2014, when it will be decommissioned. The replacement weather station, called Silver Salmon Lakes, Alaska, was set up in July 2013.

Figure 32. Hickerson Lake RAWS – The hike from the helispot is challenging and takes about an hour. It should not be attempted when the ground is wet from rain.

When the Hickerson Lake weather station is removed it will probably make the most sense to sling the weather station to the ranger cabin at Chinitna Bay. It is not possible to land a helicopter at the weather station. The helicopter can land at the small wetland described above and personnel can hike to the weather station. The helicopter can then sling two empty cargo nets to the weather station site and return to pick up the sling nets and transport the station to Chinitna Bay.

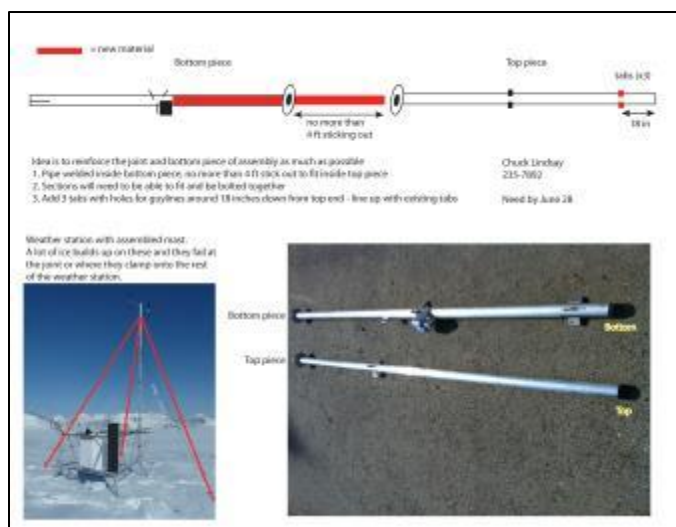
A helicopter from Homer was used for access. The station was in fair condition – the solar panel, tipping bucket rain gauge, and wind speed sensor had issues. This solar panel should be replaced during the next maintenance visit because it has a small crack on the upper mounting bracket. The mast was replaced with a new one that had been reinforced by welding a smaller diameter aluminum pipe inside the mast (Figures 35 and 36) in order to reinforce the junction which has broken on three occasions in the past. All guy-wires and associated hardware were also replaced. The AT-RH sensor, WS sensor and cable, WD sensor and cable were replaced. The wind sensor had failed on March 7, 2013 because the bearing seized due to corrosion. Regardless, both wind sensors on this station are replaced each year because of the harsh conditions at the site. A WD sensor direction test was done. The tipping bucket mechanism had broken off inside the tipping bucket. This probably happened because of icing. As a result no precipitation was documented after December 12, 2012. The tipping bucket was replaced, the rain count for the tipping bucket was zeroed, and a tipping bucket test was done. The adjusting bolt on the tipping bucket mounting arm broke while leveling the gauge. In the future, a spare mount should be carried during every maintenance visit. All data in the data logger were downloaded to send to the WRCC in order to update the archive. Several elements on the GOES antenna were replaced because they had fallen out (Figure 37). This antenna uses the larger diameter elements and the whole antenna should be replaced during the next maintenance visit. All bolts on the station were checked and tightened if loose and all cables were zip-tied. Station observations and GOES transmission quality were checked before departure. Observations and transmissions were verified from the WFMI website and relayed by satellite phone. Before departure the station was photographed from eight directions (every 45°, Figure 38) and the inside of the instrument enclosure (Figure 39) was also photographed.

Figure 35. McArthur Pass RAWS – Description of custom modifications made to the 20 foot mast that supports the wind sensors.

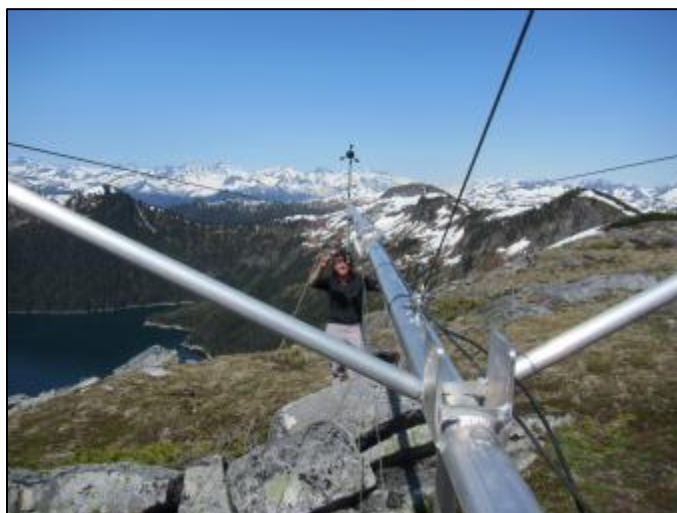
Figure 36. McArthur Pass RAWS – Kris Holderied replacing the 20 foot mast that supports the wind sensors.

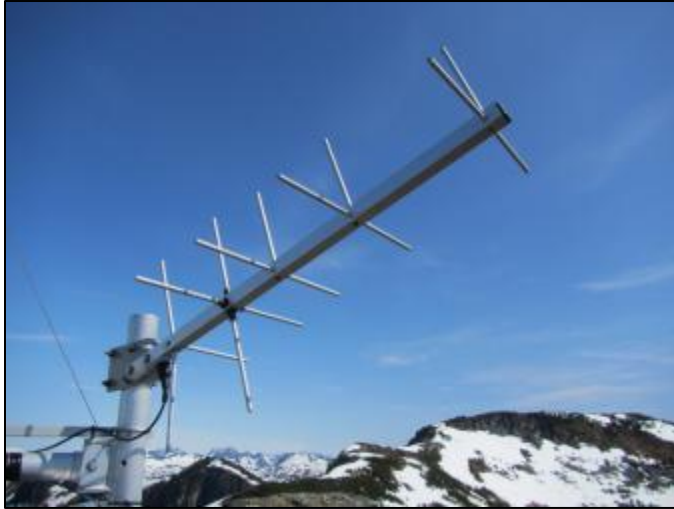
Figure 37. McArthur Pass RAWS – The newer-style FTS GOES antenna. Several of the antenna elements had fallen out. The NIFC RAWS Depot will not maintain this antenna model, claiming that it is 'disposable' – they prefer to maintain only the model with the smaller diameter antenna elements.

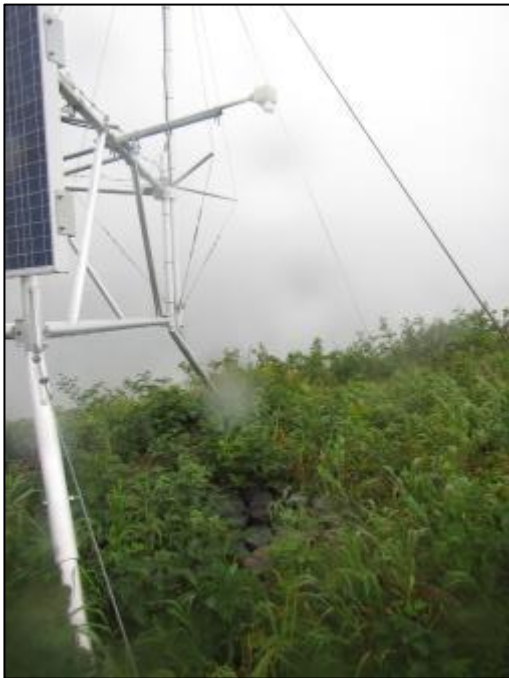
Figure 41. Pedersen Lagoon RAWs – Abundant vegetation grows around the weather station each summer. Plant growth is documented by the snow depth sensor which recorded a growth spurt beginning on June 19.

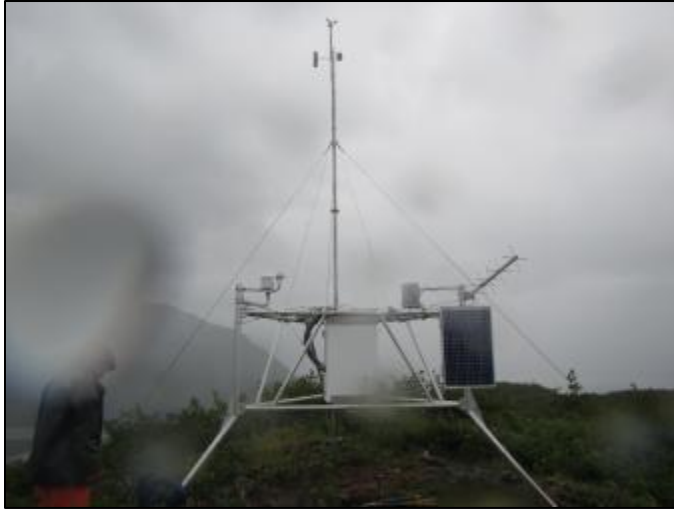
Figure 42. Pedersen Lagoon RAWS – Station after maintenance viewed from the south. Although difficult to see, vegetation beneath the station was trimmed.

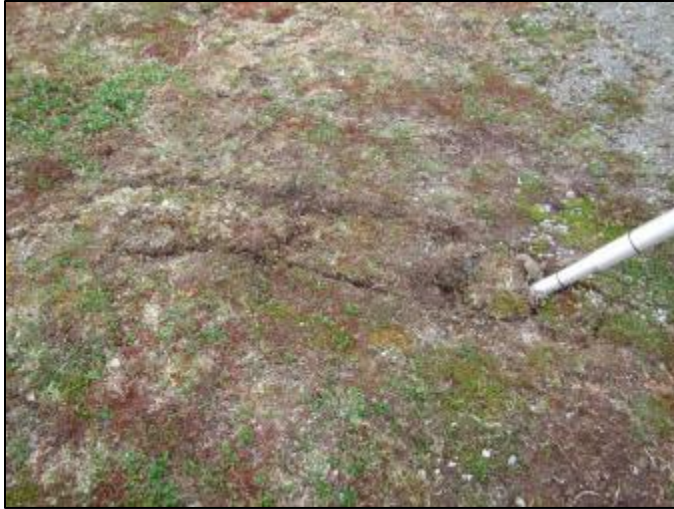
Access to the Pfaff Mine weather station was by park wheel plane. The station was in fair shape – the AT-RH and soil temperature sensors were acting up. The second (50 cm) soil temperature sensor stopped working on July 11, 2012 - shortly after it was installed (soil temperature sensors are currently only installed at two stations but will be added to other stations where adequate soil depth is present in the future). Anomalous air temperature readings (e.g. 140 and -60 C) were present almost continuously from May 30, 2013 through the date of this maintenance visit and were unfortunately not resolved during this visit. The AT-RH sensor was replaced. The WS and WD sensor cables were replaced because they were showing signs of wear. A wind direction test was done. The rain count was zeroed, and a tipping bucket test was done. The SD sensor was replaced with a Campbell Scientific SR50A SD sensor, which had been rehabbed with new transducer plates and desiccant. The dual soil temperature probes were replaced at the same location and depth of 10 and 50 cm (Figure 44). The SDI-AM module was also replaced (Figure 45). Data logger program PFMI_DLP_SR50A_SoilTemp.prg was edited to zero snow depth and operate the soil temperature sensors (transmitted element No. 17 corresponds to Temp1 in the data logger program and this is the soil temperature at 10 cm depth. Transmitted element No. 18 corresponds to Temp2 in the data logger program and this is the soil temperature at 50 cm depth). SD was zeroed to an average reading of -0.5 inches to account for fluctuation without reporting misleading snow depth readings. All data were downloaded to send to WRCC in order to update the archive. Station observations and GOES transmission quality were checked before departure. Unfortunately, after the maintenance anomalous air temperature, snow depth, and battery voltage were still present. Observations and transmissions were verified from the WFMI website and relayed by satellite phone. The diagnosis was that the data logger needed to be replaced, but a spare was not available. All bolts on the station were checked and tightened if loose and cables were zip-tied. Before departure the station was photographed from eight directions (every 45°, Figure 46) and the inside of the instrument enclosure (Figure 47) was also photographed.

Figure 44. Pfaff Mine RAWS – Vegetation mat replaced above the dual soil temperature sensors at 10 and 50 cm depth.

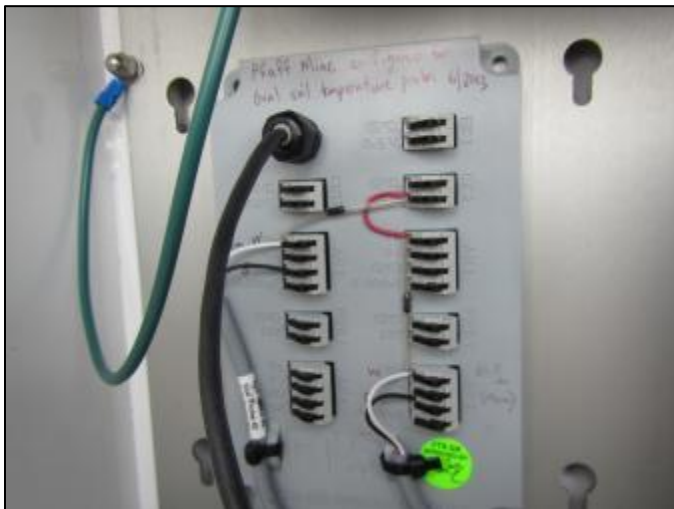
Figure 45. Pfaff Mine RAWS – Wiring configuration used on the analog/digital convertor to accommodate the dual soil temperature sensors.

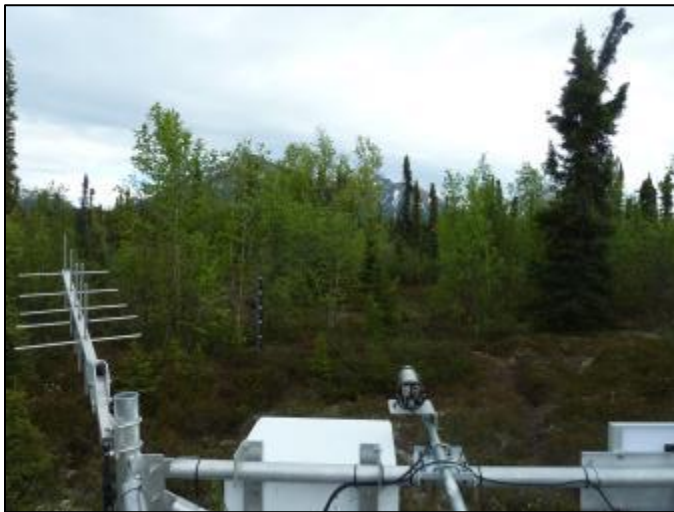
The newer Campbell Scientific time lapse camera that is mounted to the Port Alsworth RAWS (Figure 49) was maintained. The 16 GB SD card was exchanged for an empty one and the tiny desiccant packs were replaced. The camera collected 13 JPG-format photos/day, but only between August 1, 2012 and September 14, 2013 when the camera apparently stopped working. Battery voltage was <2 V. It is assumed the camera did not switch into a low power state and therefore drained the battery. The 35 Ah battery and charge controller were removed and the camera was directly connected to a standard car battery with no solar panel input. Photographs do not seem to be of good quality (Figure 50). It is not expected to successfully operate for long in this configuration. Park staff will be requested to remove the camera and mail it back for examination by the manufacturer.

Figure 49. Port Alsworth phenocam – Campbell Scientific phenocam steup (center) and snow depth stake (background).
